INTERLAKEN DAM

NDI ID NO. PA-01037
DER ID NO. 35-087

PHASE I INSPECTION REPORT NATIONAL DAM INSPECTION PROGRAM

JUNE 1981

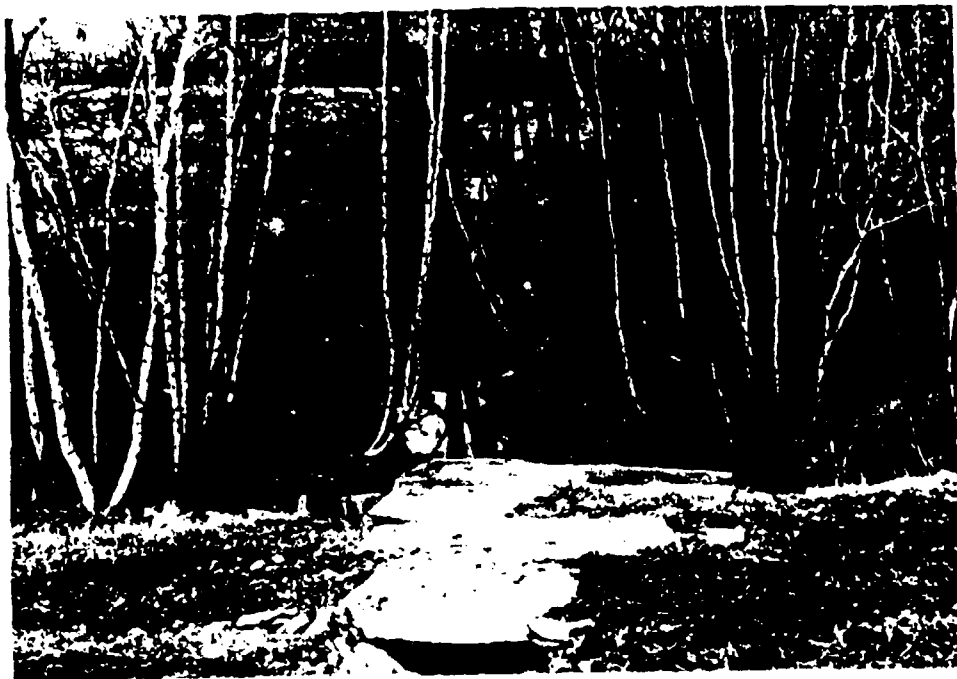
9. Discharge channel with rock culvert in foreground.

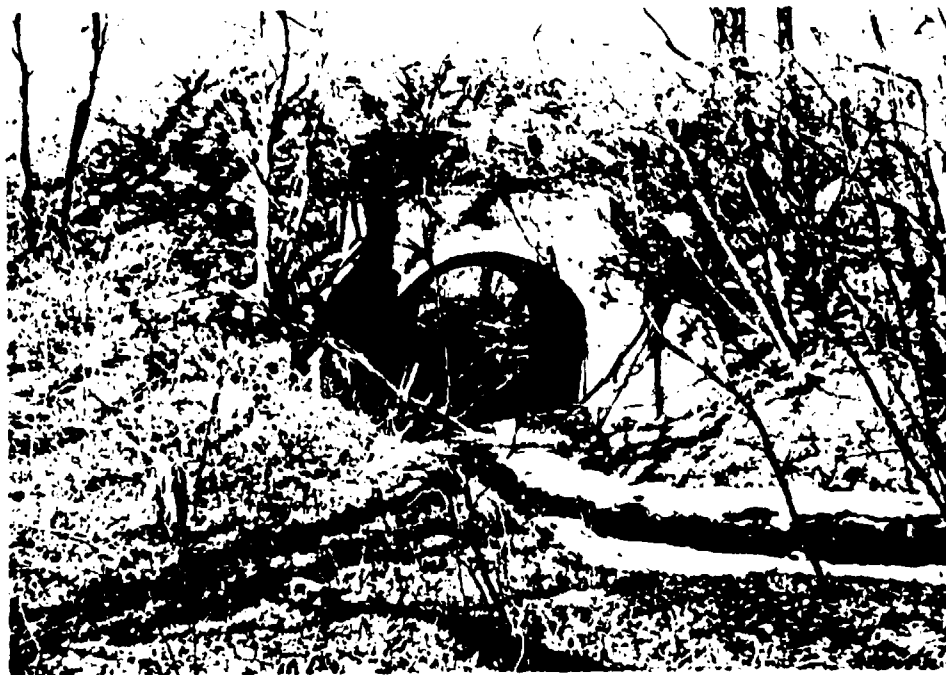
10. PA. Route 307 highway culver. (800 feet up)

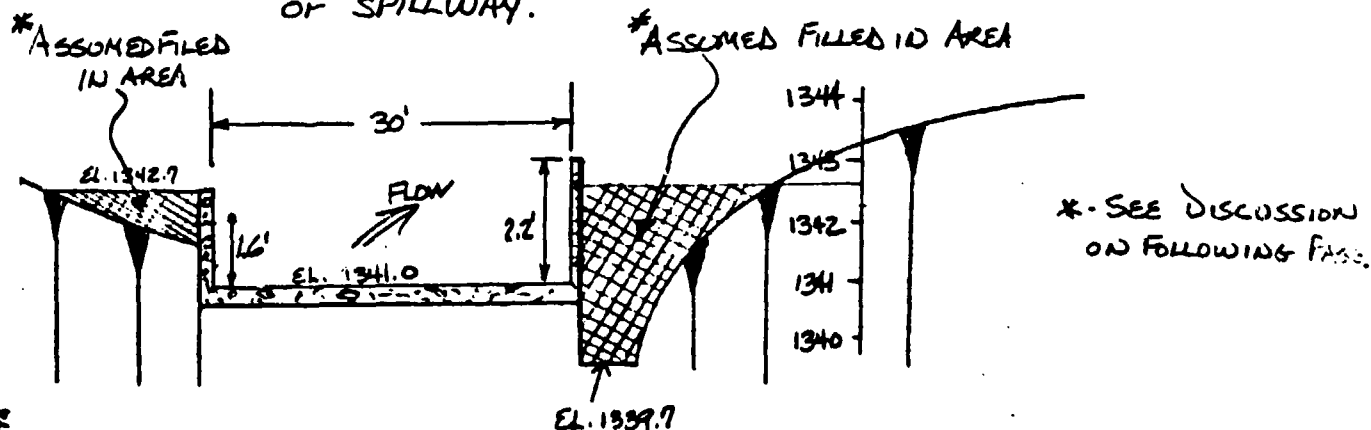
SPILLWAY SKETCH:

NOTE: UNDER EXISTING CONDITIONS THE BREACH AREA IS
DOWN TO ELEVATION 1339.7. THIS ELEVATION IS 1.3
FEET BELOW SPILLWAY CREST.
